No. FHWA-RD-78-140

DESIGN AND CONSTRUCTION OF COMPACTED SHALE EMBANKMENTS

Vol. 4 Field and Laboratory Investigations, Phase III

October 1978
Interim Report

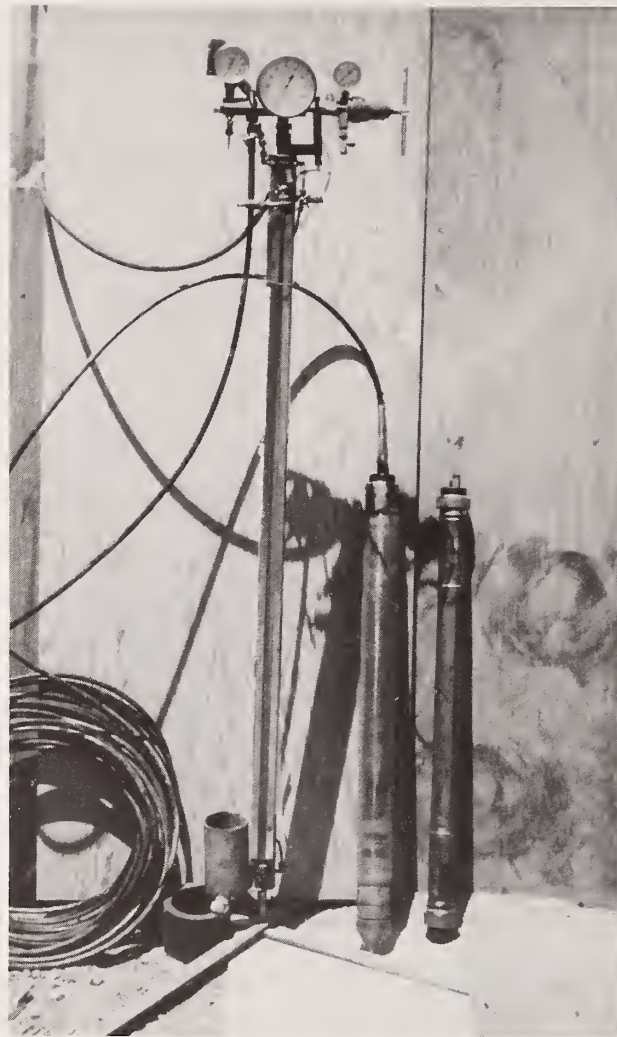
Figure 1. Menard pressuremeter apparatus
(NX size probe with urethane sheath and
bare probe on right; compressed nitrogen
gas source not shown)

15. The pressuremeter boring, located approximately 20 ft from the undisturbed sample boring, was advanced to one-half the total depth using a 2-15/16-in.-diameter tricon-roller bit and compressed air. Pressuremeter tests, using the Menard apparatus shown in Figure 1, were made at 5-ft-depth intervals downhole and then at intermediate

intervals uphole. The boring was completed to the base of the embankment, and the pressuremeter tests were completed using the same pattern as in the upper half of the boring. Test procedures and examples of test results are given in Appendix A and are summarized in Part III.

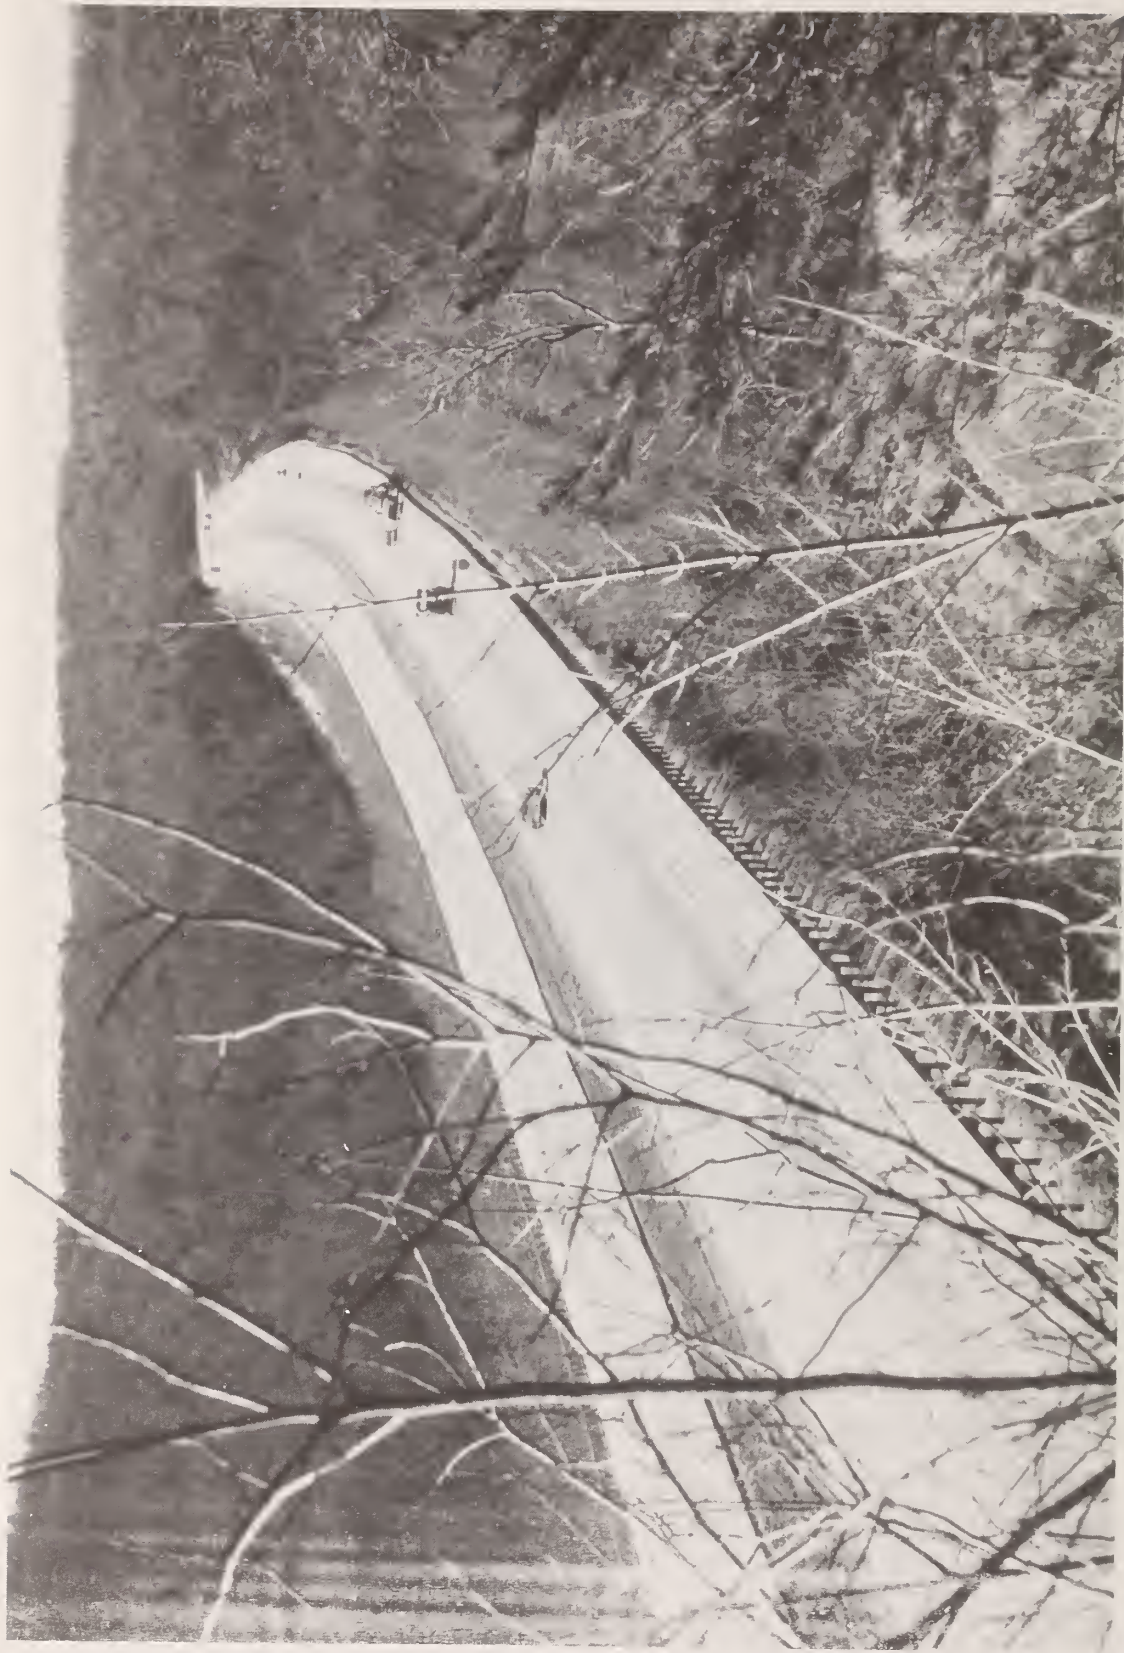
Figure 2. Tennessee I-75 embankment looking north, sta. 985 to 950

opened to traffic, longitudinal cracking developed in both the northbound and southbound lanes of the shale section of the embankment. Nonuniform settlements also occurred and required 6 in. of overlay on the northbound lane and 8 in. of overlay on the southbound lane. No further significant distress occurred. However, settlements continued, requiring periodic overlaying. The total settlement is believed to be about 2 ft. The sandstone section of the embankment showed no signs of distress.

20. WES field sampling and testing. The undistributed sample boring was located at station 960+82 on the northbound lane shoulder (Figure 2) within 18 ft of a 1972 boring by Law Engineering at station 961. The location was chosen near the lowest grade elevation for this section where maximum infiltration was possible. Undisturbed samples, Figures 3 and 4, were loose to firm and contained shale and

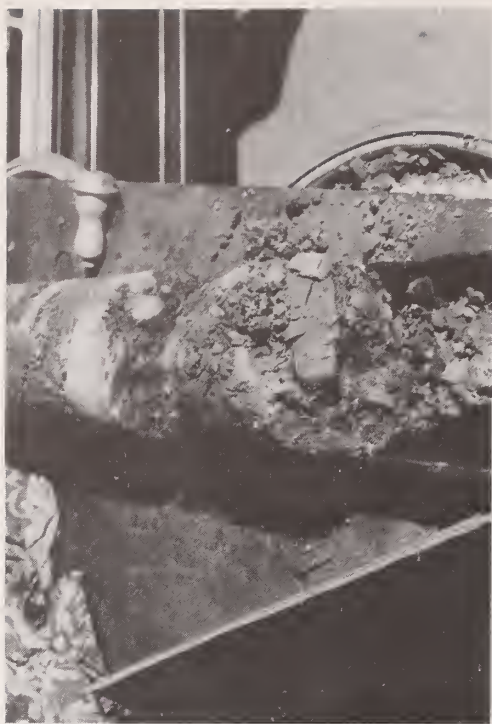
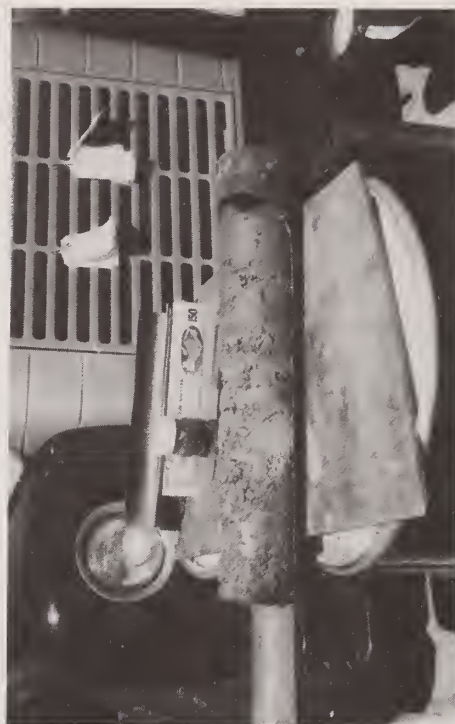
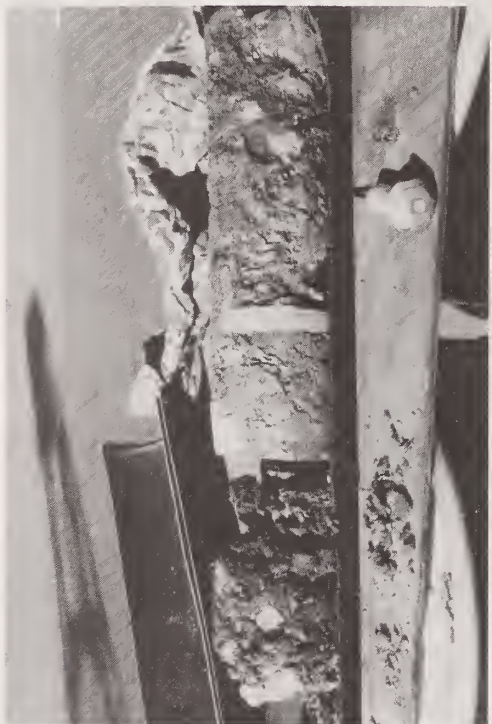
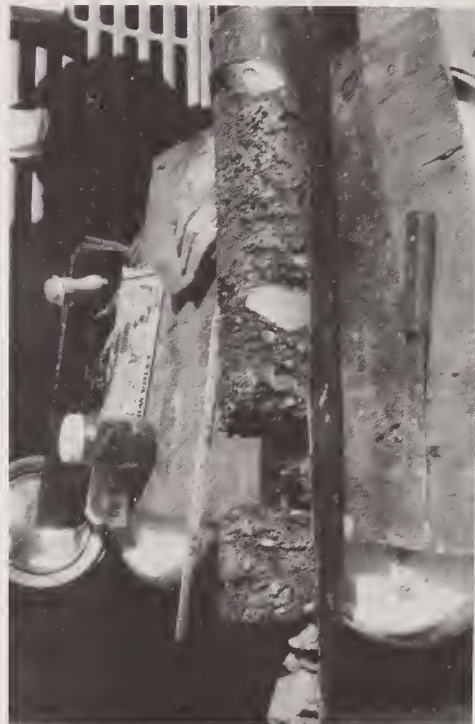
Figure 3. Character of undisturbed samples saved from Tennessee I-75 shale
embankment boring

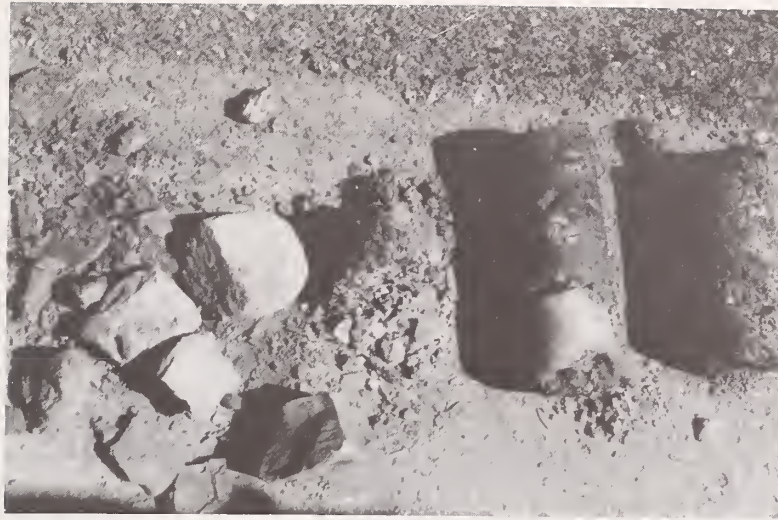
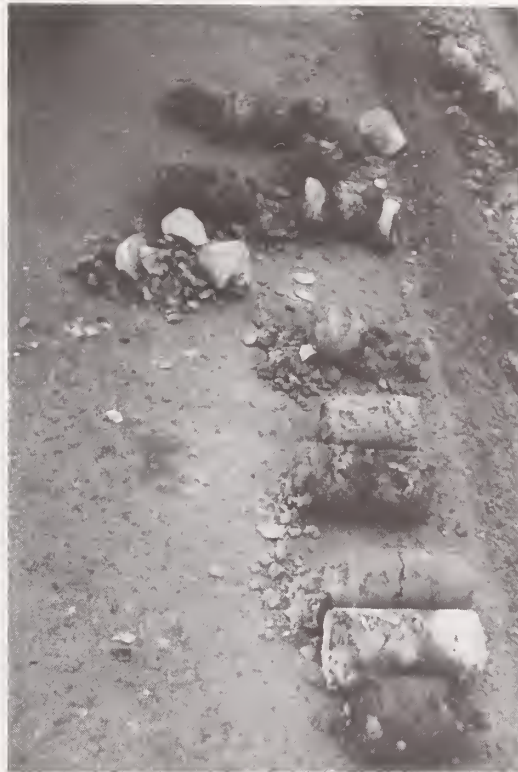
Figure 4. Character of undisturbed wasted samples from Tennessee I-75 shale embankment boring

siltstone chunks, shale fragments imbedded in gray to tan silty clay, some large pieces of sandstone (Figure 4), and occasional layers of tan to orange gravelly, silty clay. Water seepage into the borehole was encountered at 28 ft and at 78 ft after drilling through 2 ft of sandstone chunks. The character of shale pieces ranged from hard to soft and friable with iron oxide stains and with little evidence of severe deterioration. Five loose samples fell apart when pushed from the sample tube or during placement in cardboard cylinders prior to encasing in wax. Where weathered shale foundation material was encountered, a total of 34 samples were obtained to a depth of 90 ft. Twenty-nine samples were preserved for laboratory examination and testing. The overall character of the samples indicated a heterogeneous mixture of soil from weathered overburden, shale, and occasional sandstone boulders. It appeared that considerable soil and finer grained shale pieces were mixed with harder shale and siltstone chunks and with sandstone boulders during construction. It was apparent that the loosely compacted material settled and increased in water content from infiltrating surface water.

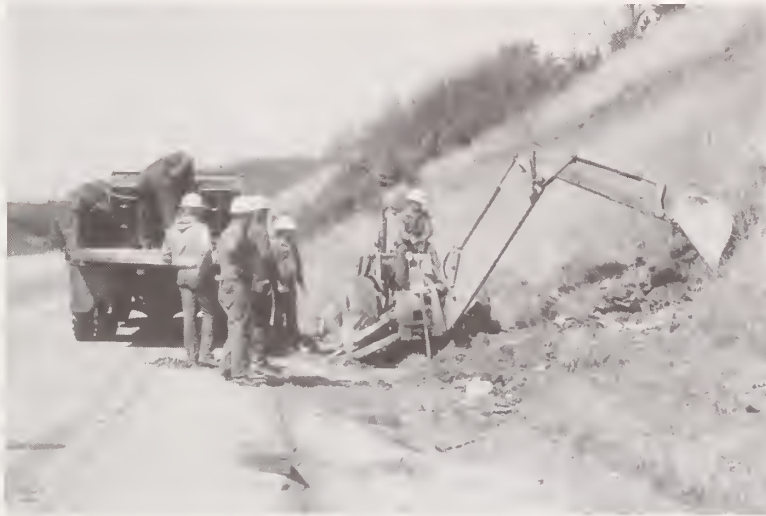
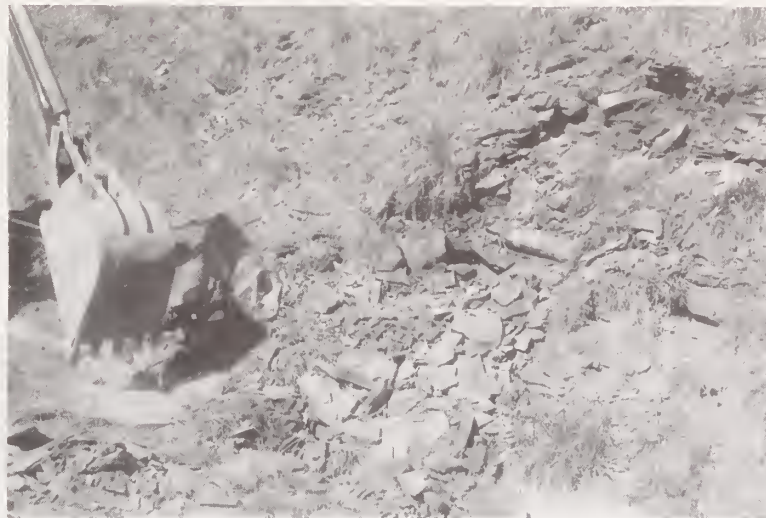
Figure 5. Excavating unweathered parent shale chunks, Tennessee I-75

22. Parent shale samples were obtained from two cuts south of the embankment between stations 820 and 950. Highway department personnel indicated that overburden soil, weathered shale, and siltstone from the upper portions of the cuts had been placed in low areas to build up the grade northward toward the large shale embankment. Shale and siltstone from the lower sections of these cuts were then hauled to the shale embankment section. Unweathered chunks of the shale in the cut near the ditch were broken out using a backhoe operated by State highway district personnel (Figure 5). This shale was dark gray and hard, and corresponded to hard chunks of shale found in the embankment samples. Two

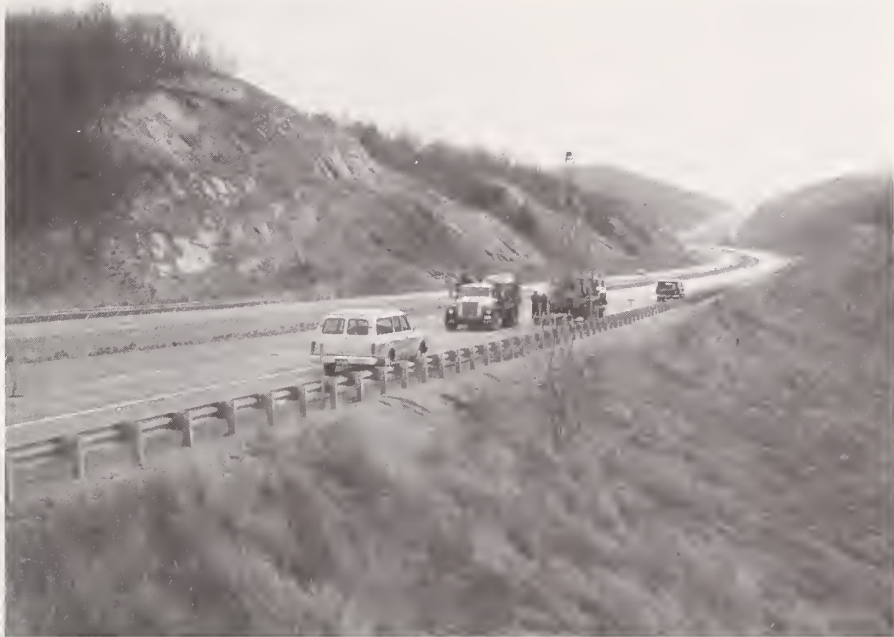
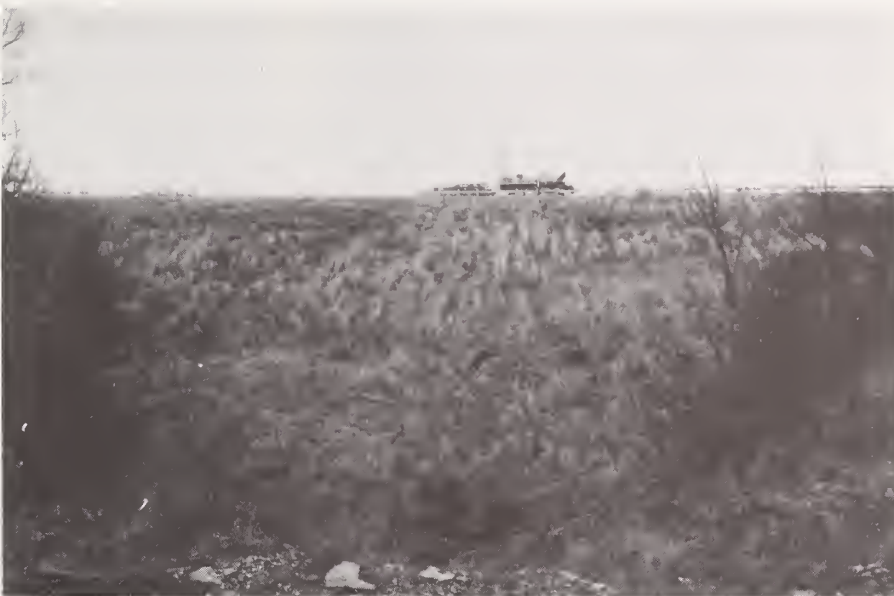
Figure 6. U. S. 460 West Virginia embankment

25. Performance. Shortly after concrete paving was completed in early 1971, settlement depressions were evident in four of the embankments including the one from stations 551 to 555+50. The concrete was replaced with asphalt pavement, and the section was opened in the fall of 1971. Pavement settlement at the center of the

embankments required overlays in 1972 and 1973. Settlements continued at a rate of about 6 in. per year until mid-1975. Total settlement for the highest embankment (200 ft) was approximately 25 in. and was attributed to the breaking down of shale and the consolidation of soil layers caused by subsurface seepage from uphill terrain and infiltration of surface water.

27. WES field sampling and testing. The undisturbed sample boring was located on the shoulder (Figure 6) at station 553+75 within 25 ft of the State highway boring at station 553+50. Undisturbed samples (Figure 8) were loose to dense mixtures of clay, gravel-size pieces of gray to black shale and brown siltstone, and occasional large pieces of hard shale, siltstone, sandstone, and limestone. Brown silty clay and siltstone predominated. Shale deterioration (Figure 8, 66.5 to 67.5 ft) was minor compared to the mixture of materials which appeared to have

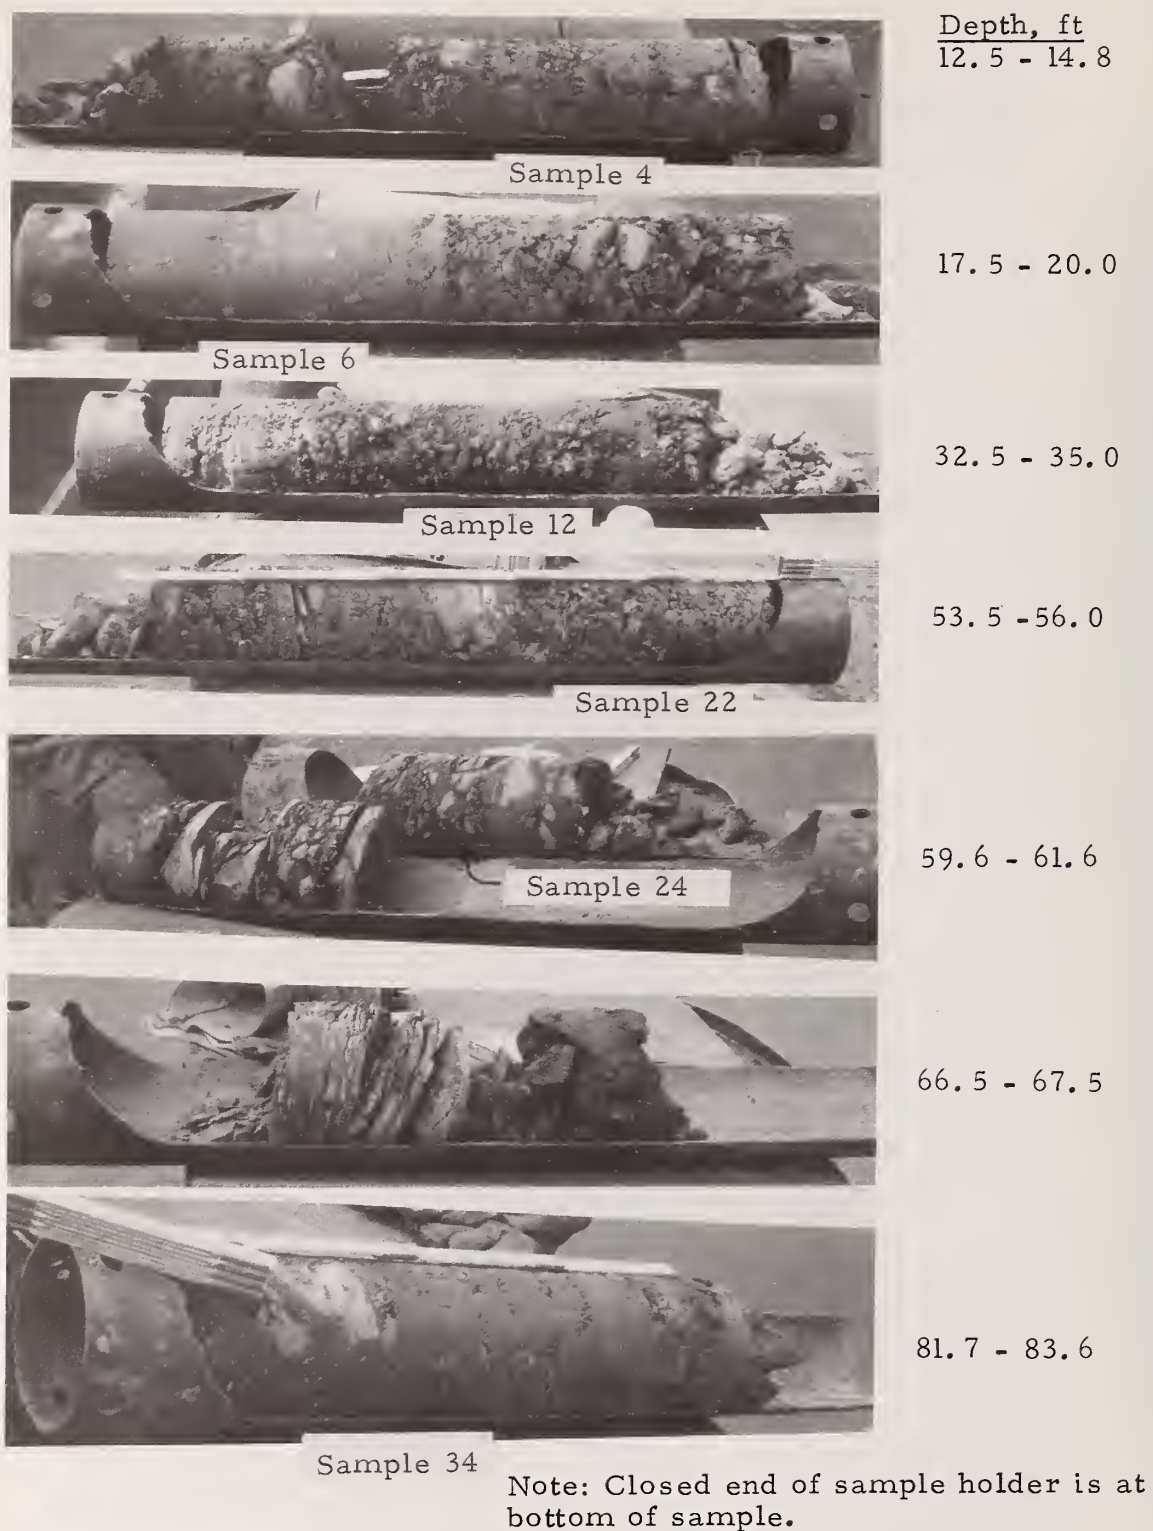
Figure 8. Character of undisturbed samples, West Virginia,
U. S. 460 shale embankment

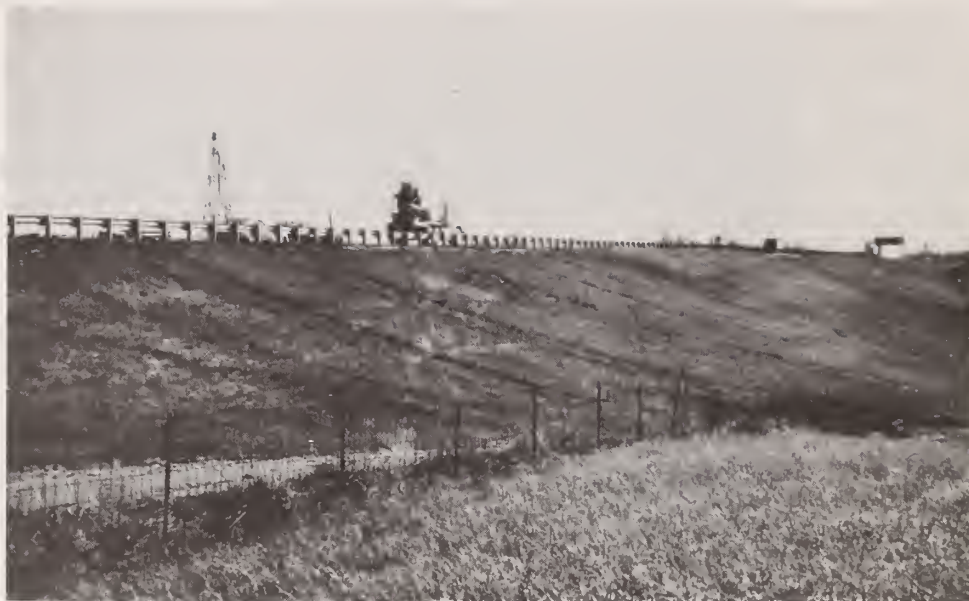
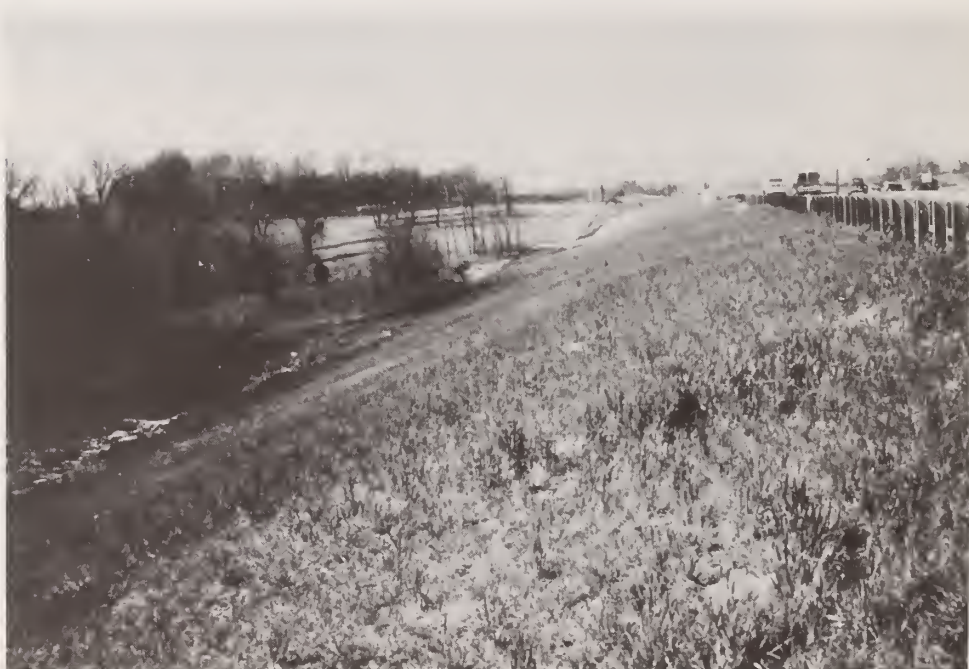
Figure 9. General view of I-75, Kentucky shale embankment after reconstruction MP 179.7 to 179.9

32. Performance. Shallow shoulder slides were repaired in 1968 using wood piling and old guardrail. Intermittent pavement overlaying was required to maintain grade; and in 1973, the guardrail retaining wall slumped away from the shoulder. Quarry stone was used to rebuild the shoulder; and permanent reconstruction to 4:1 slopes was accomplished in 1974.

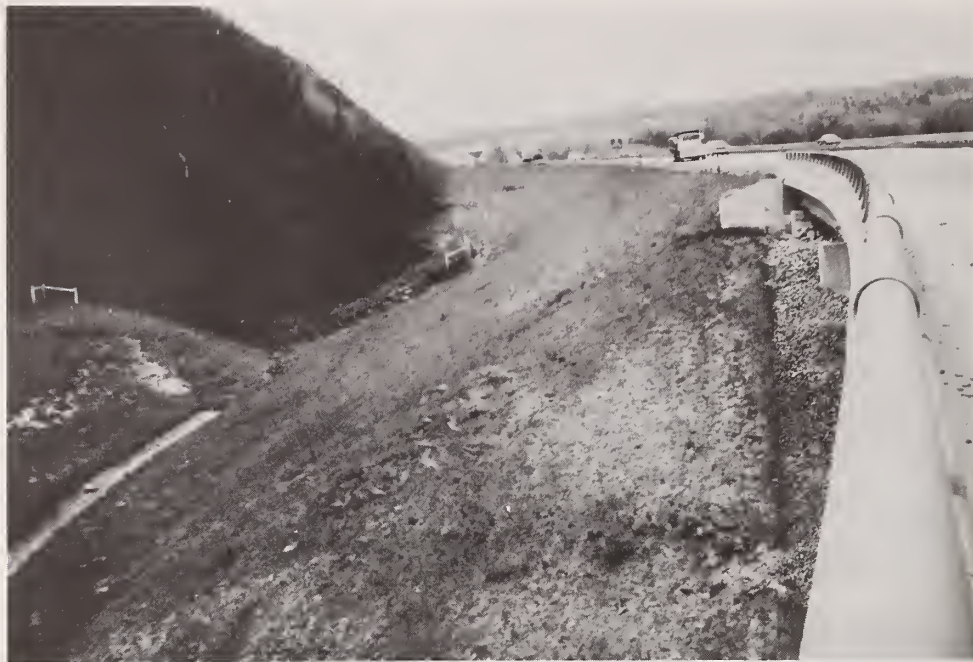
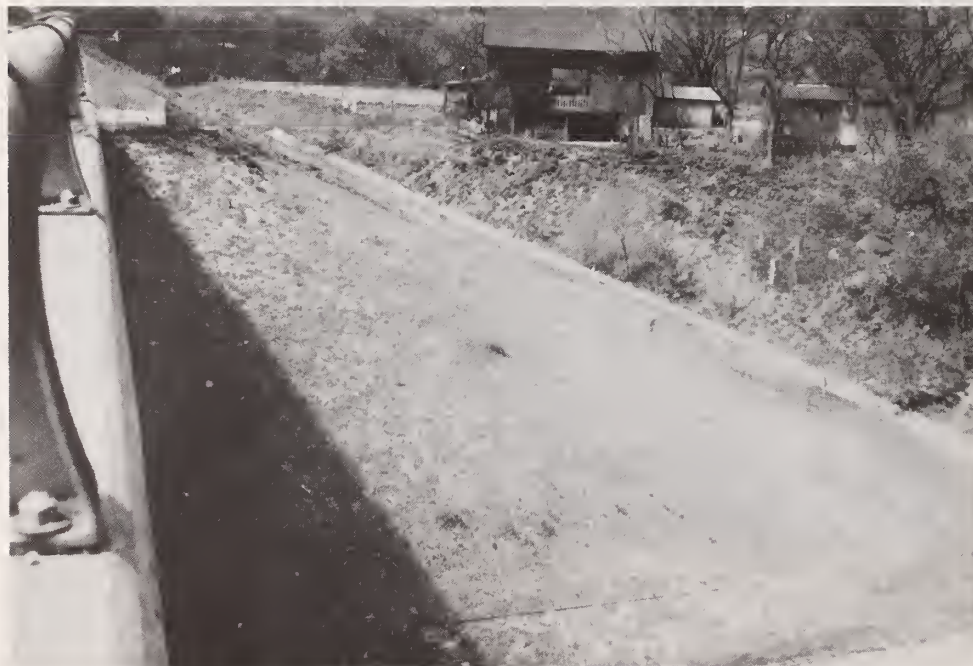
Figure 13. West approach embankment I-74, Ohio
at Wesselman Road

at the bridge abutments occurred from 1962 to 1968. Settlement of the soil foundation (80 ft to bedrock) may have contributed to the problem, since 15 ft of soft foundation material was removed at the start of construction. A test pit made in 1968, after cement grouting of the embankment (very low grout take), indicated no large voids in the fill. The undisturbed sample boring was located in the median of the west approach embankment at station 492+00, 75 ft west of the abutment. The samples included loose to firm, dark-gray to brown shale chunks and gravel-size pieces, with clay and limestone chunks and layers of tan to brown, silty clay. Pictures of the sampler were not made. The condition of shale pieces ranged from hard to soft and friable. Twenty-one samples were obtained to a depth of 55 ft, where stratified, dark-brown, clay foundation material was encountered. Sixteen samples were preserved for laboratory examination and testing. Sixteen valid pressuremeter tests were performed to a depth of 35 ft at station 492+15. Modulus values ranged from 1000 to 4000 psi, and undrained shear strengths ranged from 2000 to 8000 psf. Test results are discussed in Part III. Two barrels of unweathered, gray, shale chunks were taken from the source cut in the Kope formation at the west end of the embankment.

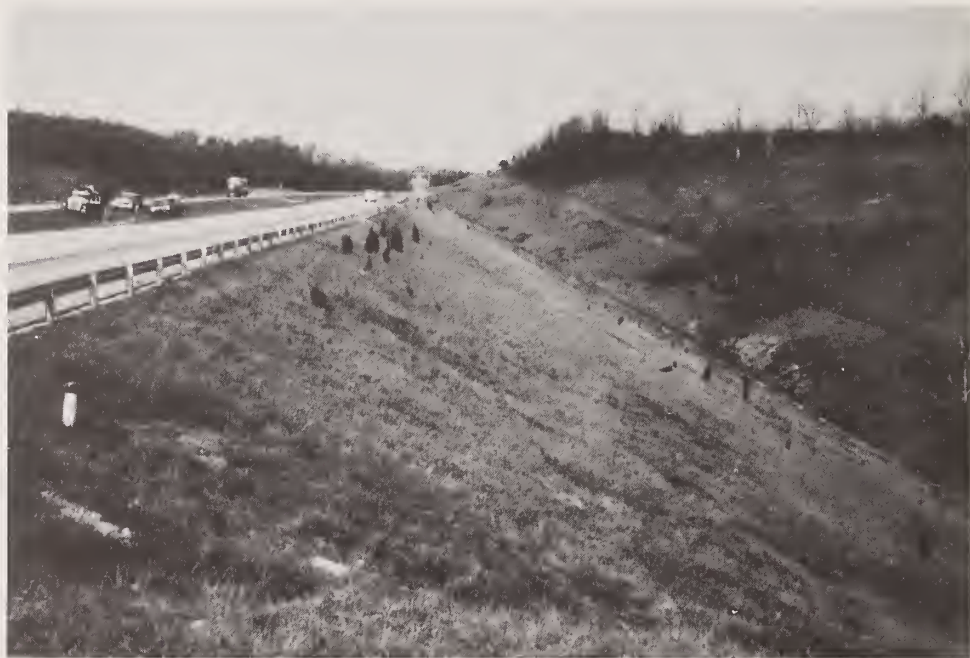
Figure 14. Indiana I-74 embankment, sta. 426+00 to 440+40
(north slope, looking west)

40. Cause of settlement. Settlement data summarized by EDCE from ISHC records and measurements during 1975 and 1976 indicated a maximum settlement of 2.2 ft in the westbound lane at station 434+00. This location is over the sidehill foundation area where the embankment height is 60 ft. Lateral displacement measurements from March 1976 to May 1975 along the westbound shoulder showed 1.3 in. localized movement between stations 433 and 435. Observations of surface conditions indicated settlement around catch basins in the grass median, ponding of water in the median, and an open crack along the westbound pavement at the shoulder.

These subsurface conditions and the possible breakage of subsurface drain pipe aggravated infiltration of surface water. Test pits by EDCE in the median to a maximum depth of 18 ft showed soft, gray, clayey shale (~70 percent) and hard, gray limestone (~30 percent), with shale sizes ranging from crumbly fragments to 3-ft chunks and limestone sizes ranging from gravel to 4-ft slabs. Void sizes were 2 to 12 in., and the material appeared poorly compacted. At one location, a 2-ft layer of soft, brown, silty clay was found which is similar to residual overburden soil on natural slopes. On the north slope of the embankment, a large seepage area with shallow sloughing was evident. Borings encountered seepage water at a depth of about 30 ft, but piezometers in the embankment and the residual soil foundation layers indicated that piezometric levels remained near the base of the embankment. Thus, infiltrating surface water, following diverse paths through the loose embankment fill had softened the shale in the 10-year period since construction.

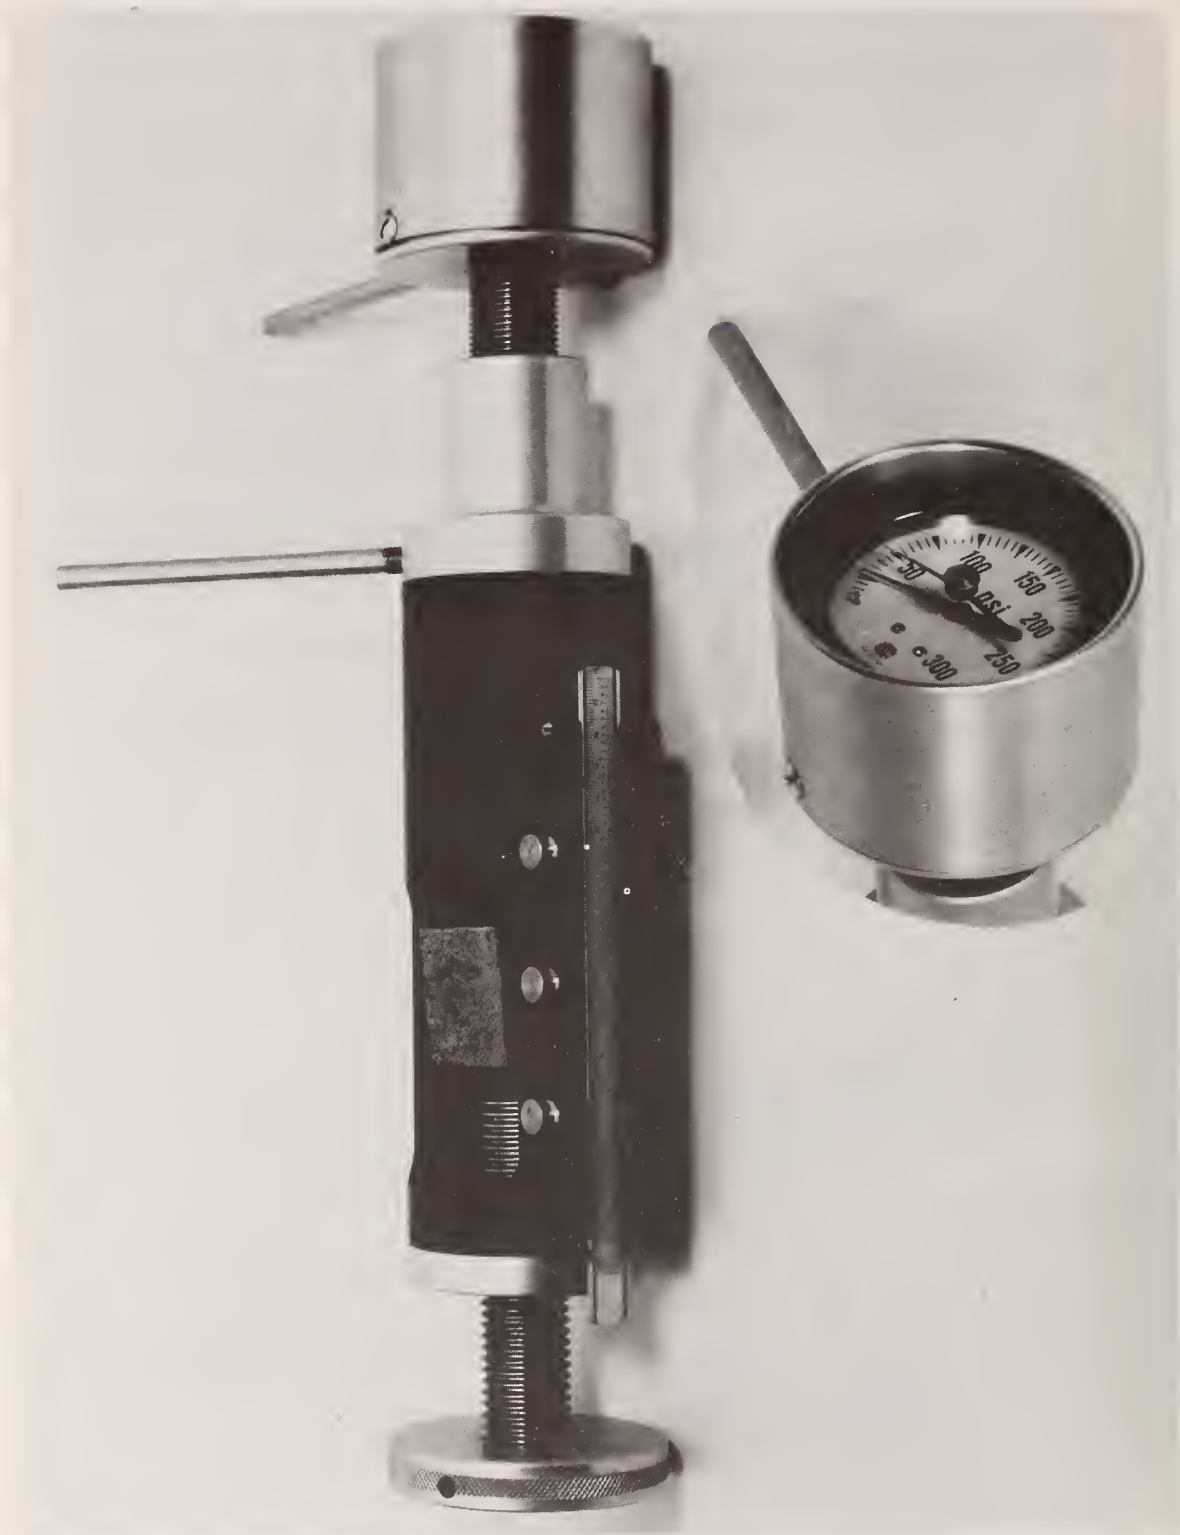
Figure 29. Hand-held point load tester
